Pelican Products Inc

TEST REPORT

NFPA 1901, Mechanical Shock, LED Charging Flashlight,
9050

104401990CRT-002

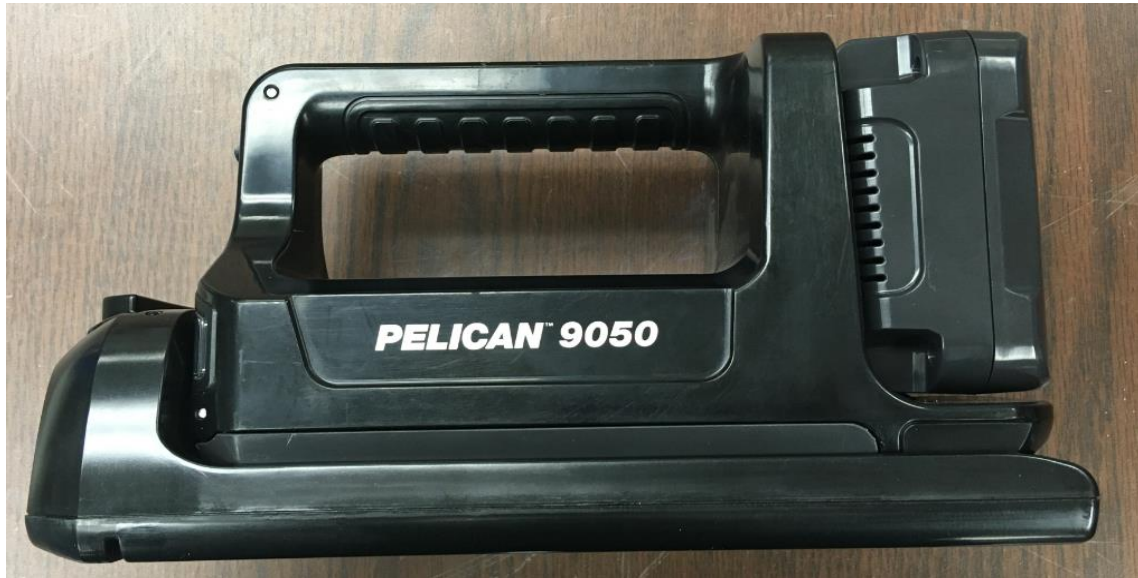
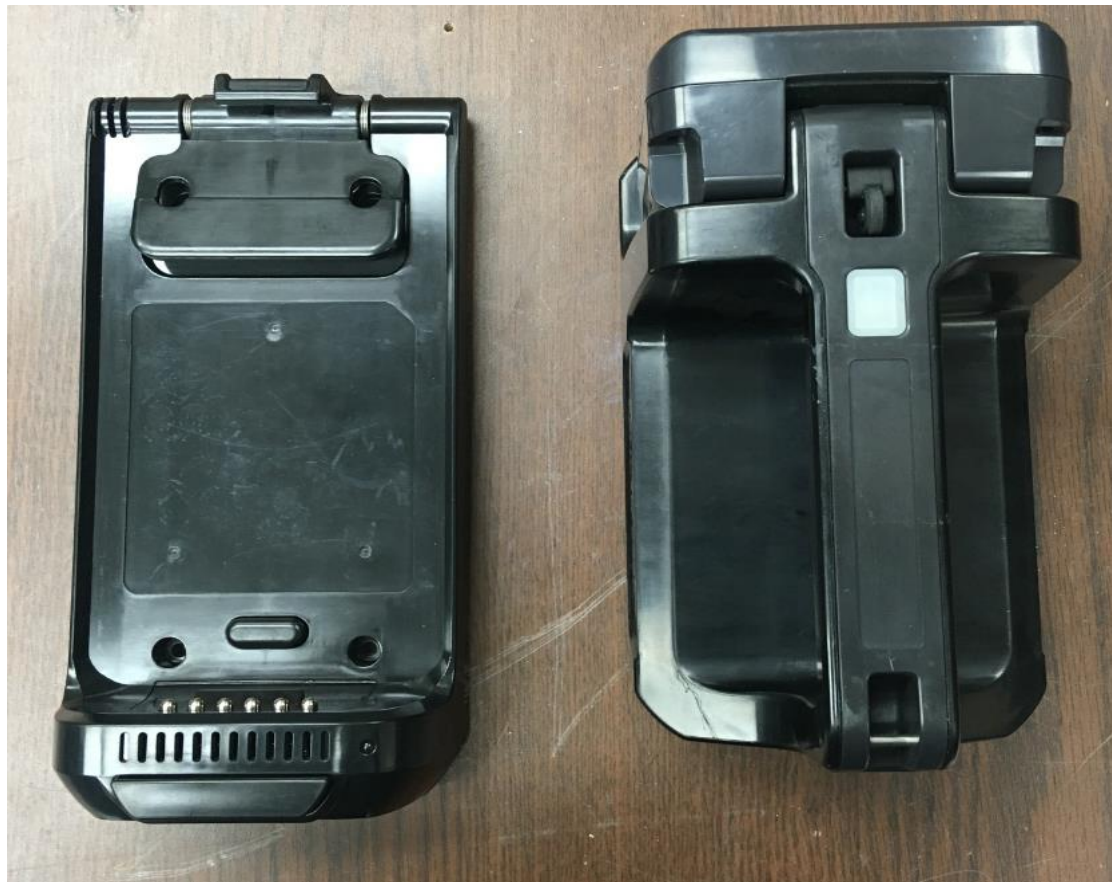
Picture(s)

Sample Information				
Date Rec.	Intertek ID	Description	Condition	Model No.
2/25/21	CRT2102251514-001-1	LED Charging Flashlight	Production	9050
2/25/21	CRT2102251514-001-2	LED Charging Flashlight	Production	9050
2/25/21	CRT2102251514-001-3	LED Charging Flashlight	Production	9050
2/25/21	CRT2102251514-001-4	LED Charging Flashlight	Production	9050
2/25/21	CRT2102251514-001-3A	LED Charging Flashlight	Production	9050
2/25/21	CRT2102251514-001-4A	LED Charging Flashlight	Production	9050

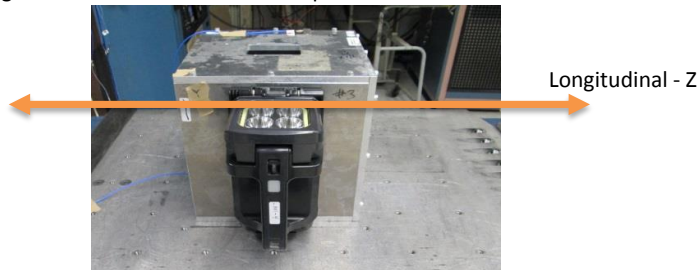
Axis	Acceleration (G)	Width-Duration	Number of Pulses	Pulse Type
Longitudinal - Z	9G	11ms	3+, 3-	Half-sine
Vertical - Y	9G / 3G	11ms	3+, 3-	Half-sine
Horizontal - X	9G / 3G	11ms	3+, 3-	Half-sine

NOTE: Axis designation is according to the vehicle not the test sample.

The test sample was mounted with the sample bracket to a test fixture which was mounted to the mechanical shock machine. The test sample was subjected to half sine shock pulses in the vertical axis in accordance with the following profile below:

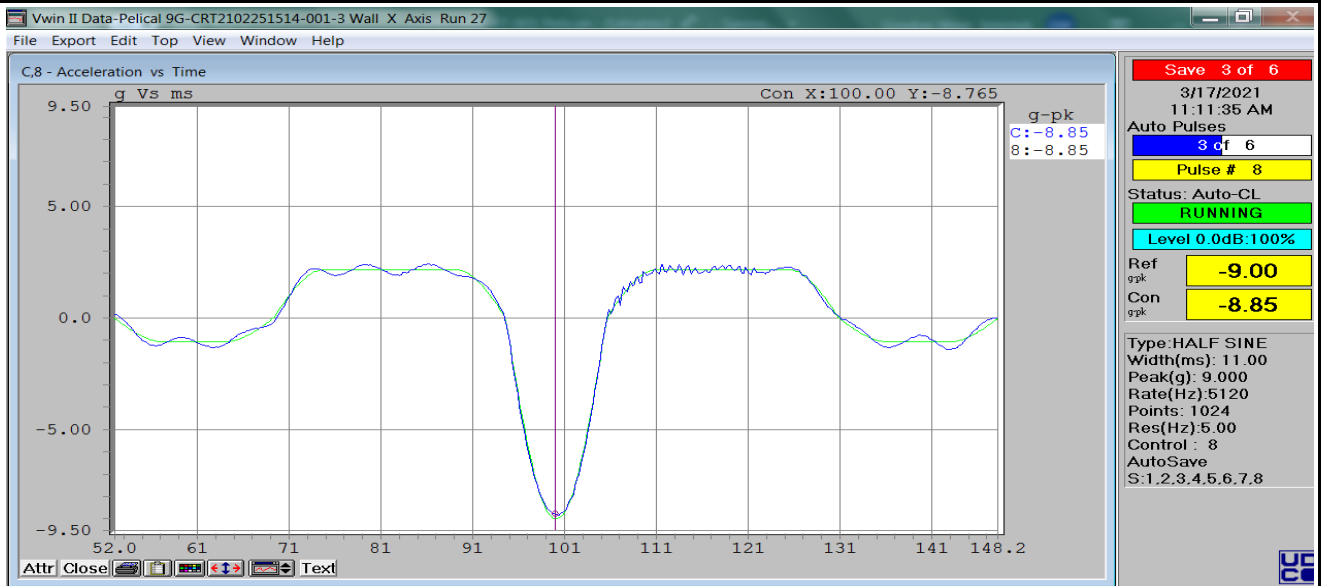
Sample Number	Test Axis	Control Channel	Monitor Channel	Bracket Mounting Location	Configuration
CRT2102251514-001-3	X Axis	8	6	Wall Mount In Vertical	4 battery

Post Test Results: The bracket and charger contained the sample, no sign of physical damage.

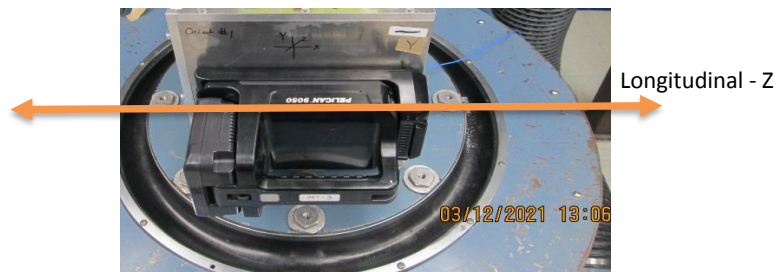
Axis	Acceleration (G)	Width-Duration	Number of Pulses	Pulse Type
Longitudinal - Z	9G	11ms	3+, 3-	Half-sine
Vertical - Y	9G / 3G	11ms	3+, 3-	Half-sine
Horizontal - X	9G / 3G	11ms	3+, 3-	Half-sine

NOTE: Axis designation is according to the vehicle not the test sample.

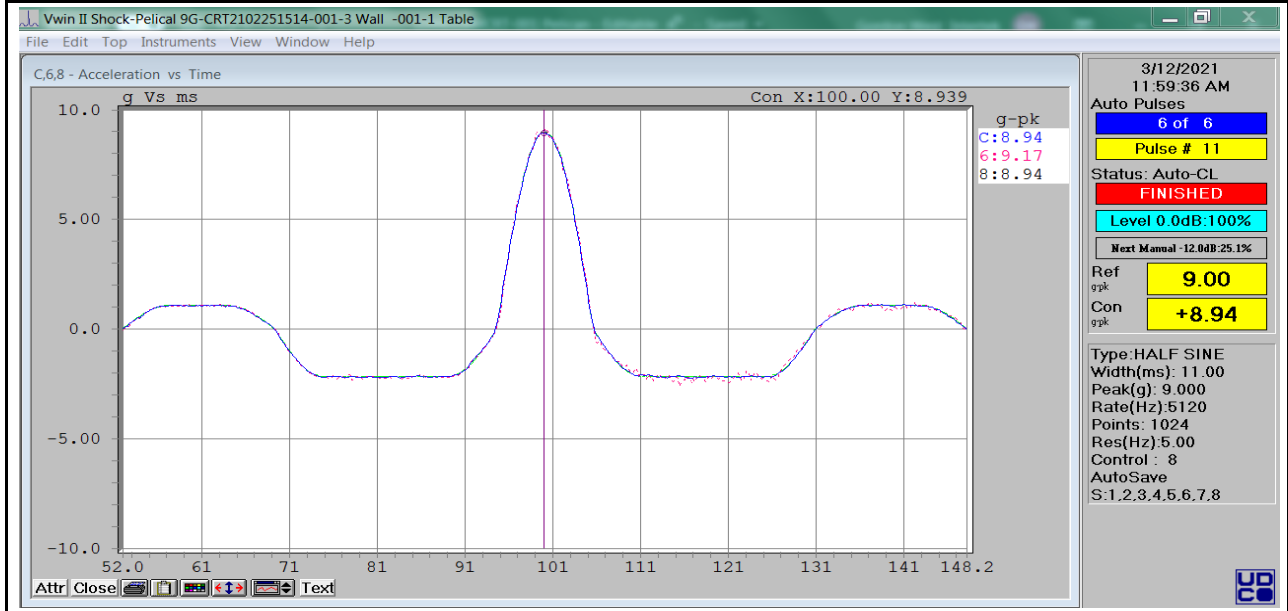
Sample Number	Test Axis	Control Channel	Monitor Channel	Bracket Mounting Location	Configuration
CRT2102251514-001-1	Y Axis	8	6	Wall Mount In Horizontal	1 lithium

Post Test Results: The bracket and charger contained the sample, no sign of physical damage.

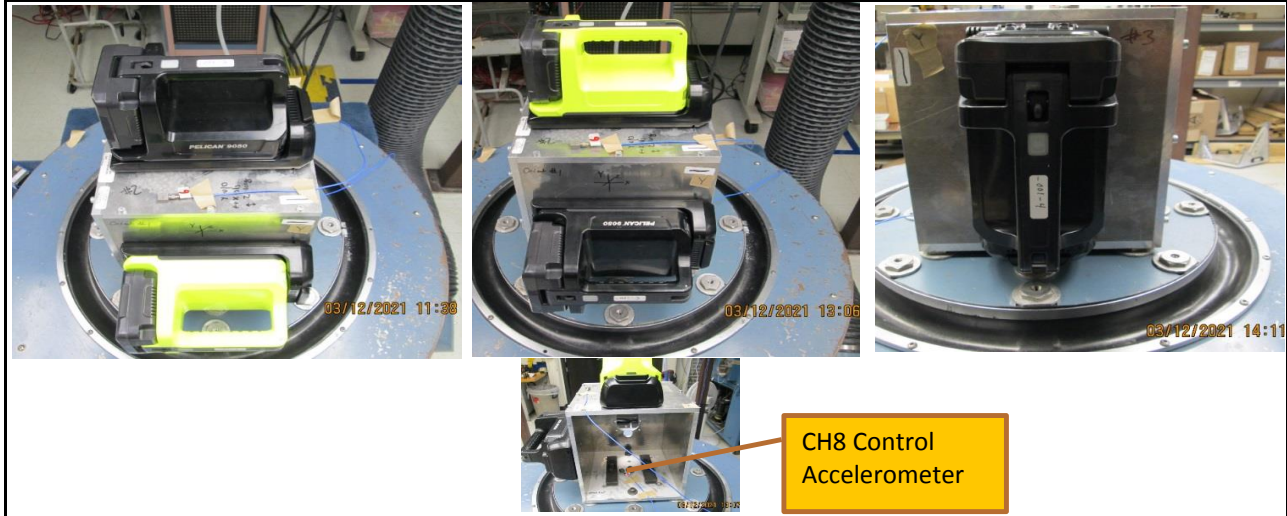
Photo: Y Axis according to the vehicle

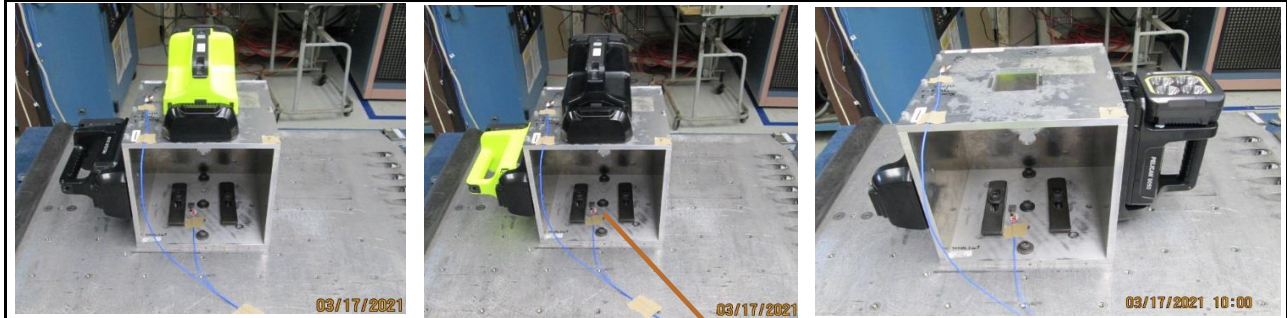
Photo: X Axis according to the vehicle

CH8 Control Accelerometer

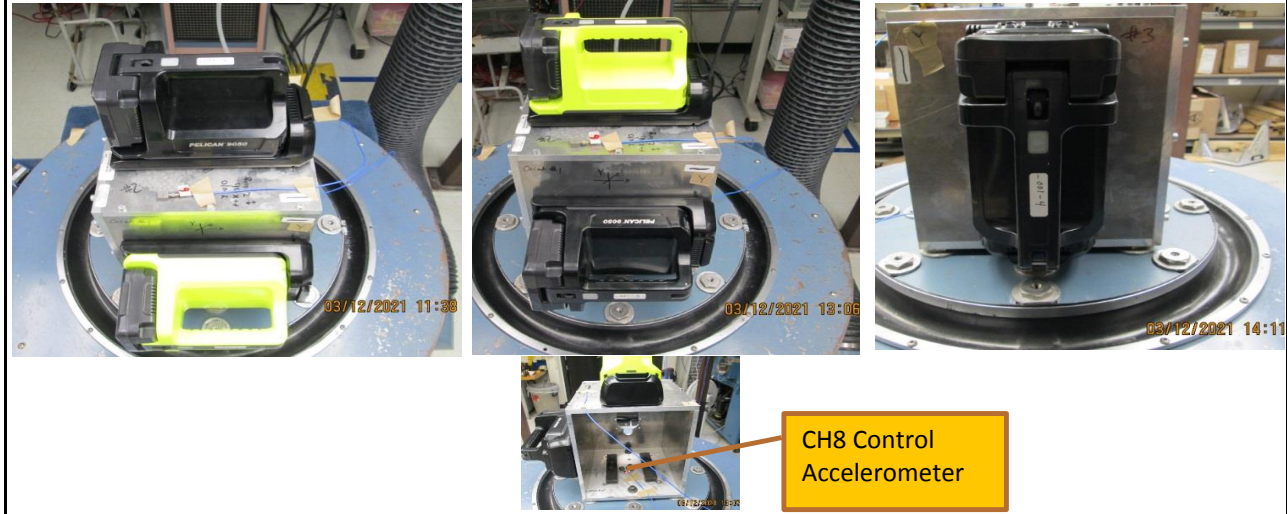
Photo: Y Axis according to the vehicle
